STABILIZATION OF MOVING LAND MASSES BY CAST-IN-PLACE PILES

John B. Palmerton

U. S. Army Engineer Waterways Experiment Station
P. O. Box 631, Vicksburg, Miss. 39180

Final Report

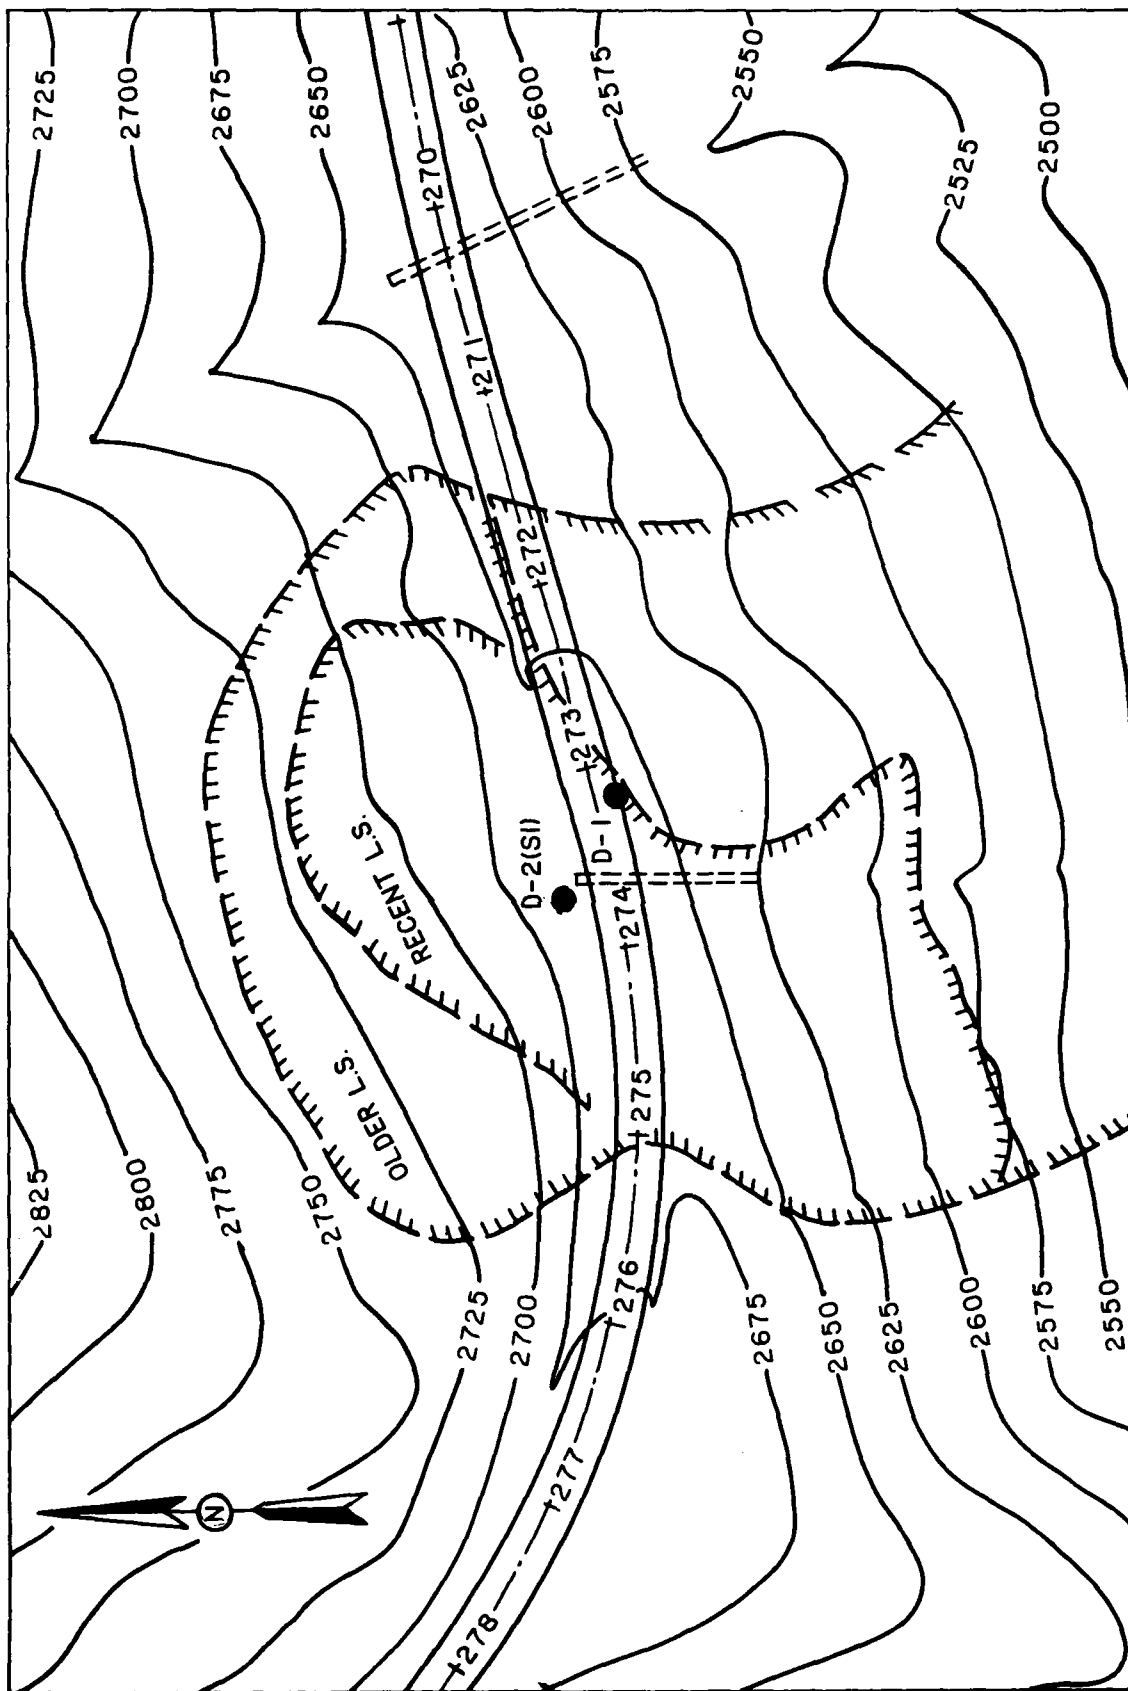
Figure 18. Topography of project site

44. Movement on the downhill side also occurred with subsequent displacements of the roadway and sidehill embankment. Cracking and pushouts of loose material can be observed for a distance of approximately 200 ft downslope (Figure 18).

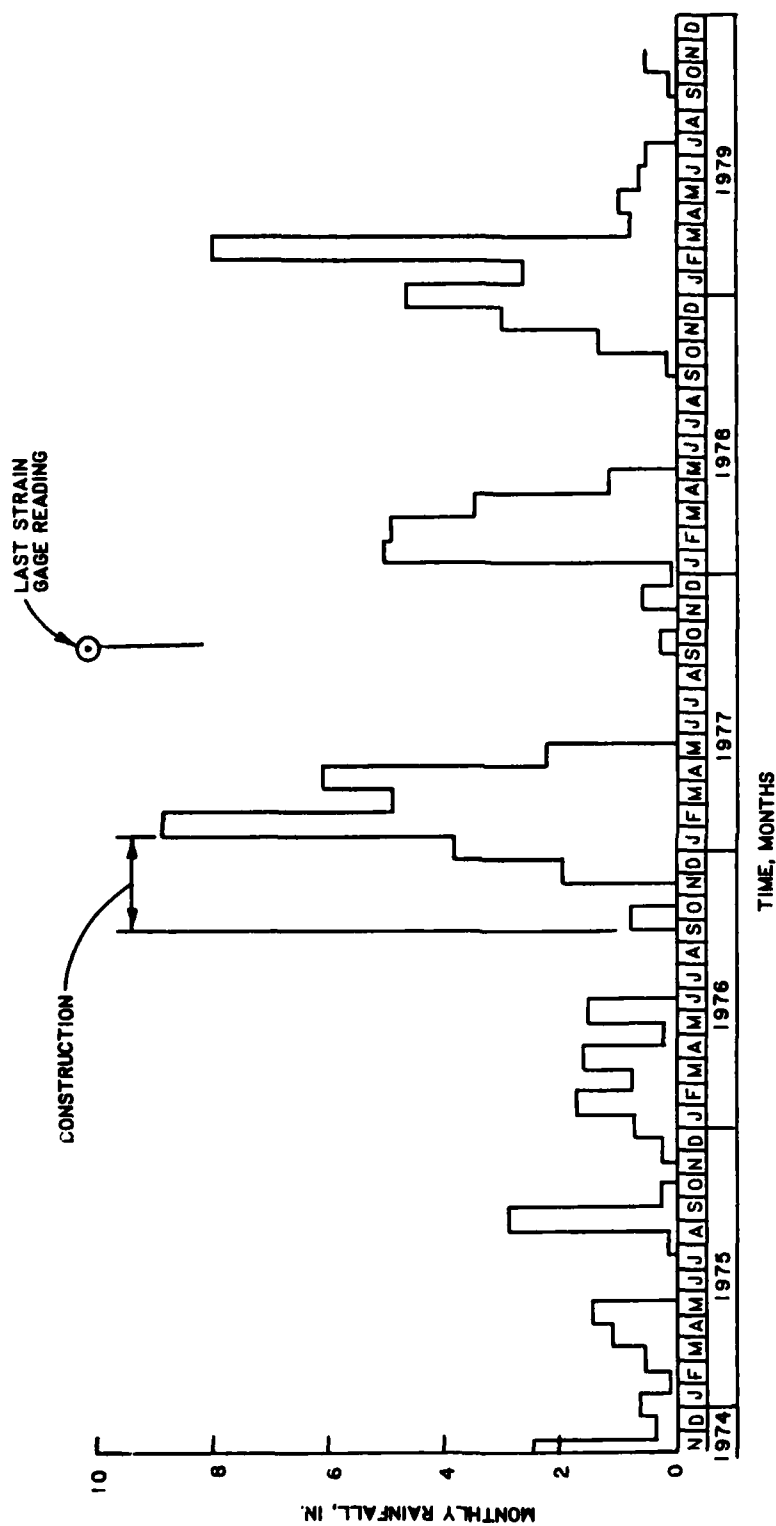
Figure 65. Rainfall data near project site

68. The rainfall data at Black Butte Reservoir are shown in Figure 65. Black Butte Reservoir is located some 20 miles northeast of the project site. Therefore, these rainfall data should roughly apply to the project site. The rainfall data indicate that the rainfall during the winter of 1978 (just following construction) was quite above the mean of the previous two years. The completed pile structure performed well during the rainy season. No cracks or movements were noted within the reconstructed roadway. Large strains, or strain buildup, within the instrumented section did not develop through the time of the last instrument readings (September 1978).

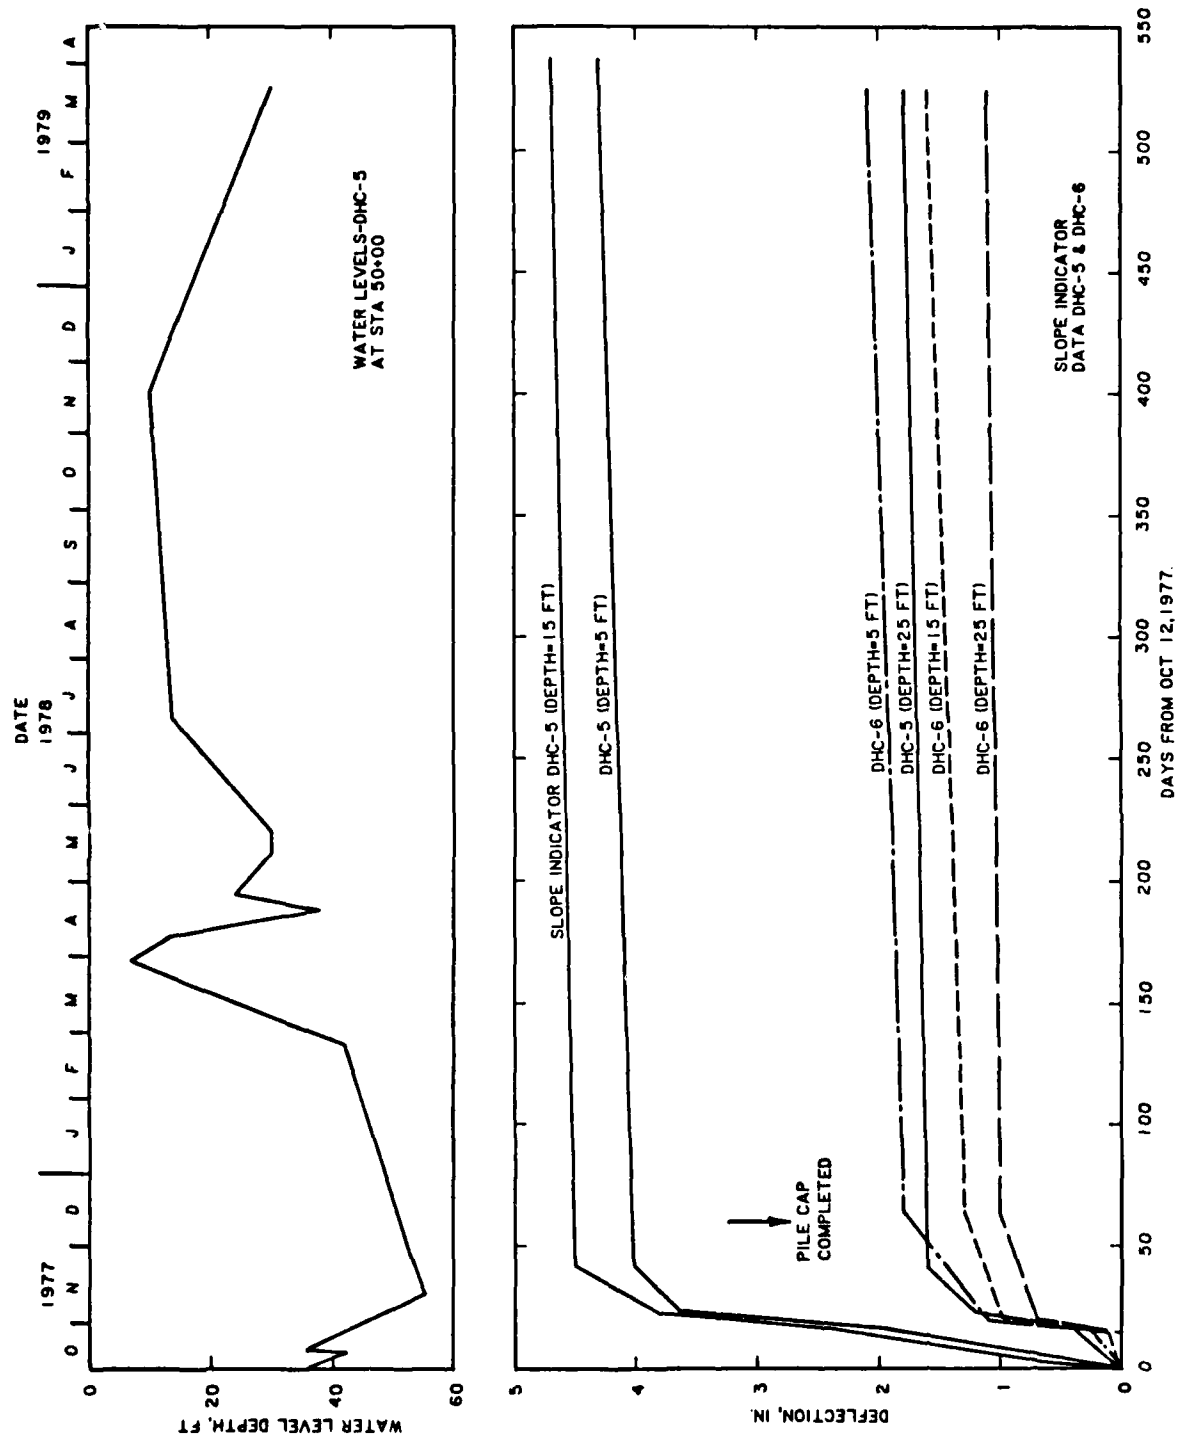
Figure 98. Slope indicator deflections and water level readings

95. The NYSDOT monitored the slide repair performance at various locations along the retaining structure. The devices installed included slope indicators and tilt plates. Water level readings were obtained from slope indicator installations. Of particular interest are the data obtained from the slope indicator hole (DHC-5) placed at station 50+00 within the area of the pile cap. The location of this slope indicator is shown in Figure 71. Another slope indicator, DHC-6, was installed approximately 25 ft east of the end of the recently constructed Sta-Wal at station 50+50. The data from these two slope indicators, plotted as depth versus deflection, are shown in Figure 97. The readings shown are from the start of construction to April 1979. (The cut off date of April 1979 was chosen since movements had essentially ceased by that time.) The slope indicator movements plotted as deflection versus time for selected depths and water level elevations versus time are shown in Figure 98.

97. The time histories (Figure 98) show that the movements markedly decreased after the installation of the pile cap. This relative lack of movement is also consistent with the decrease in strain gage output following the placement of the pile cap. The water level recordings, also shown in Figure 98, show an increase in water level during the spring (1979) months. However, this increase in water level did not cause an associated landslide movement.
